CIRCULAR OF THE BUREAU OF STANDARDS C450

UNDERGROUND CORROSION

By Kirk H. Logan

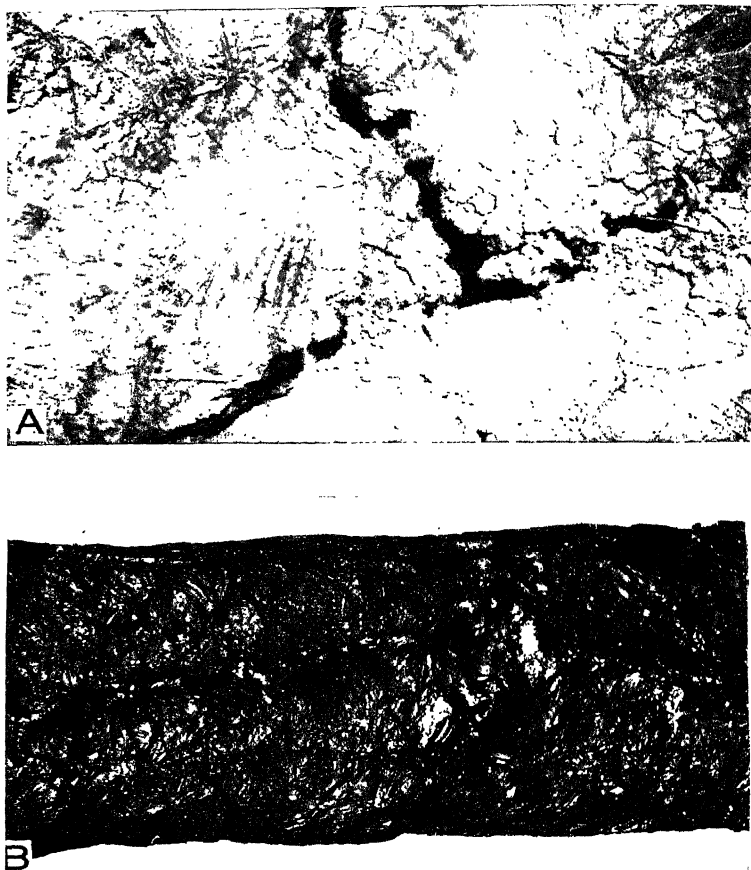
FIGURE 3.—*Soil cracking and its effect on a pipe coating.*

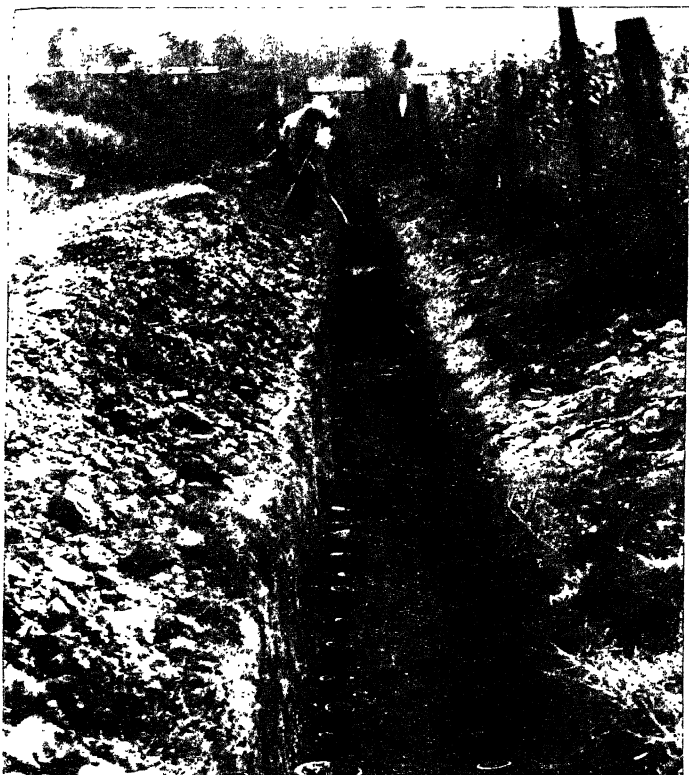
FIGURE 4.—Burial of soil corrosion specimens near Alexandria, Va., in 1922.

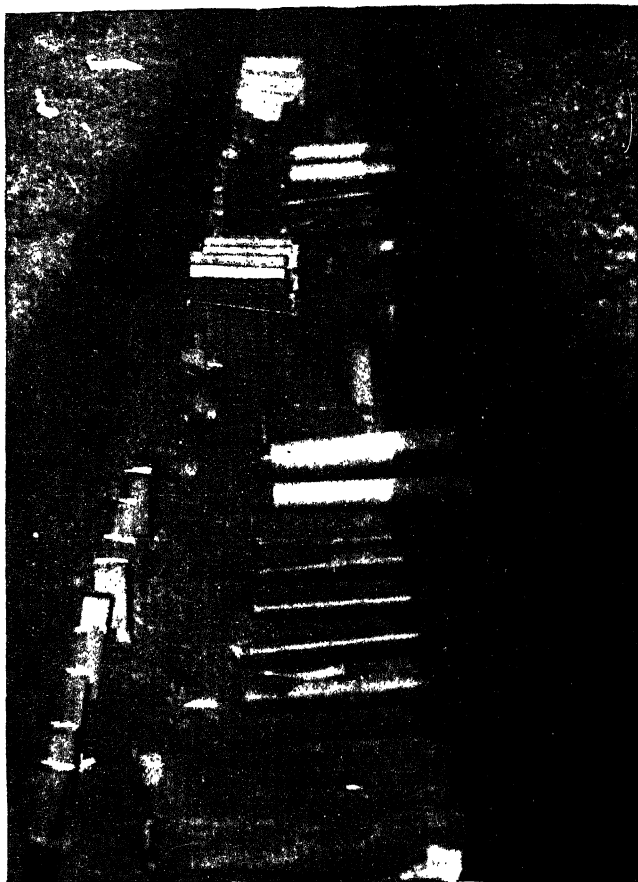
FIGURE 5.—*Arrangement of specimens buried in 1934*
Note two soil horizons.

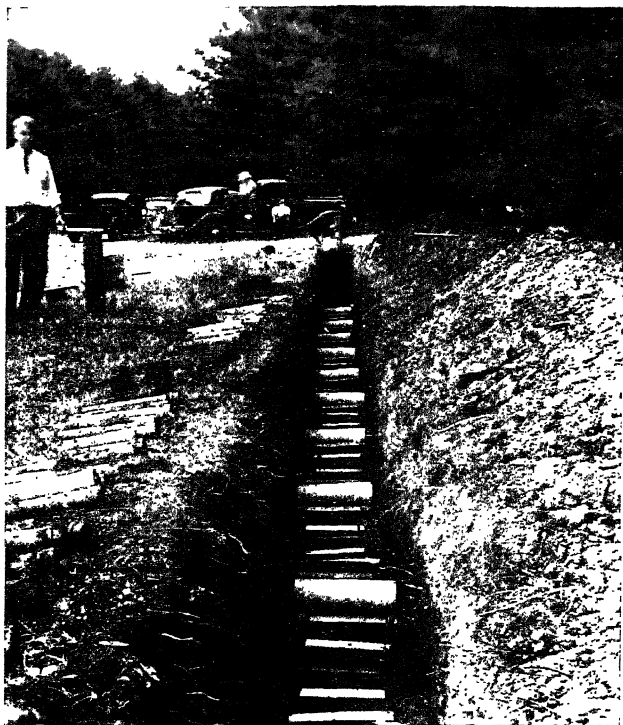
FIGURE 6.—Arrangement of specimens buried near Baltimore, Md., in 1932.

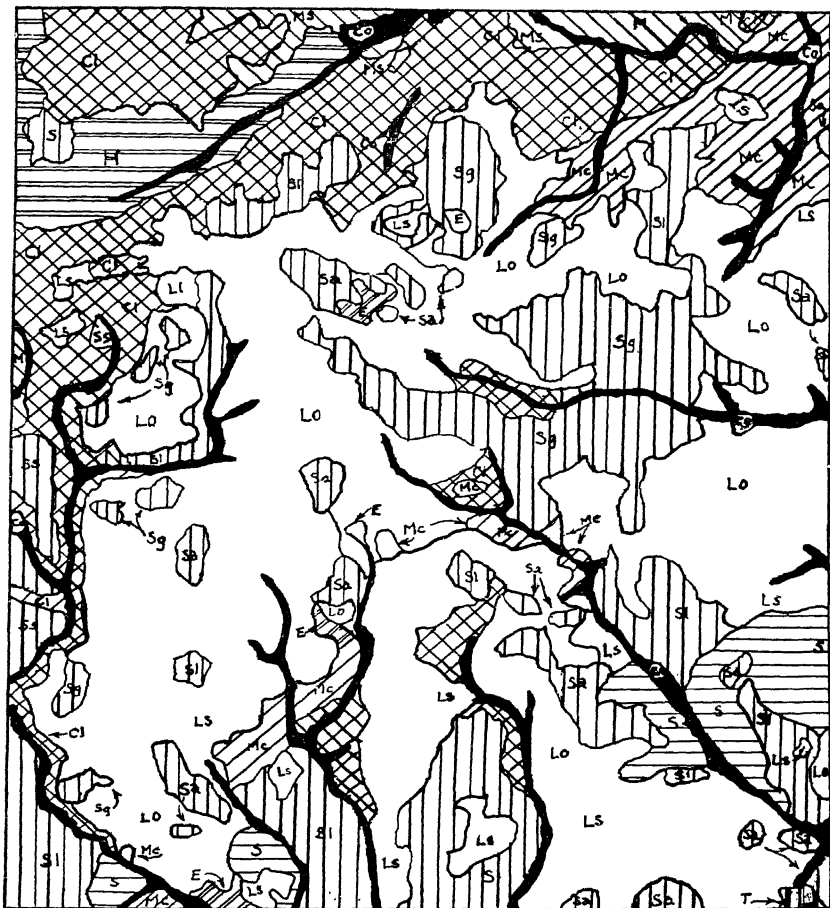
FIGURE 7.—Soil series in a 6- by 7½-mile area near Baltimore, Md.

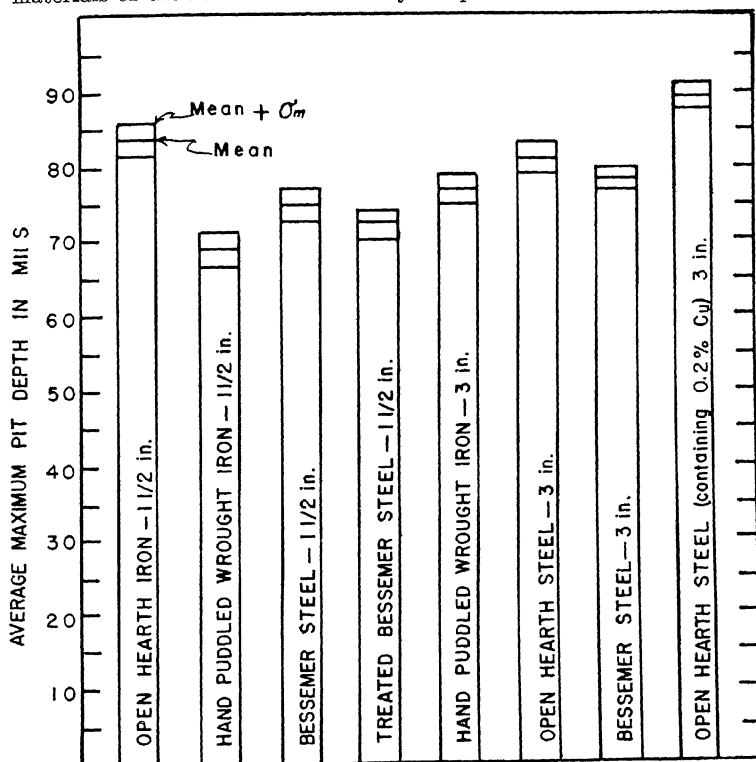
FIGURE 11.—Average maximum pit depth on wrought pipe for 12 years of exposure; 23 soils.

Figure 11 indicates also that the maximum pits are generally deeper on the 3-inch than on the 1½-inch specimens, but tables 39 and 40 show that this is not always the case.

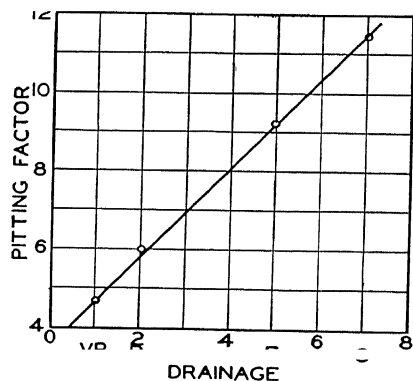
FIGURE 12.—Correlation between pitting factor and drainage.

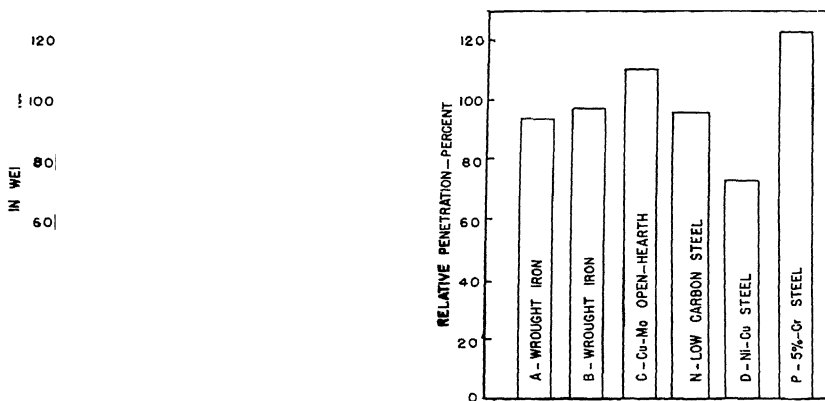
FIGURE 13.—Relative loss of weight and maximum penetration of wrought ferrous for four periods of exposure.

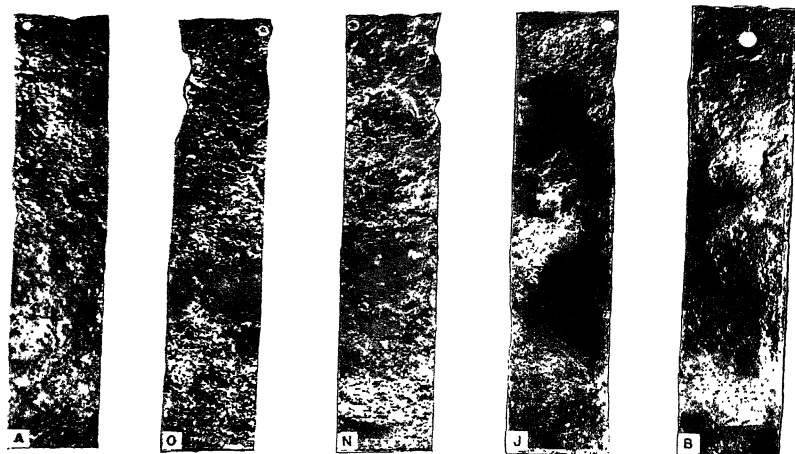
FIGURE 16.—Ferrous plates exposed 4 years to Merced silt loam at Buttonwillow, Calif.

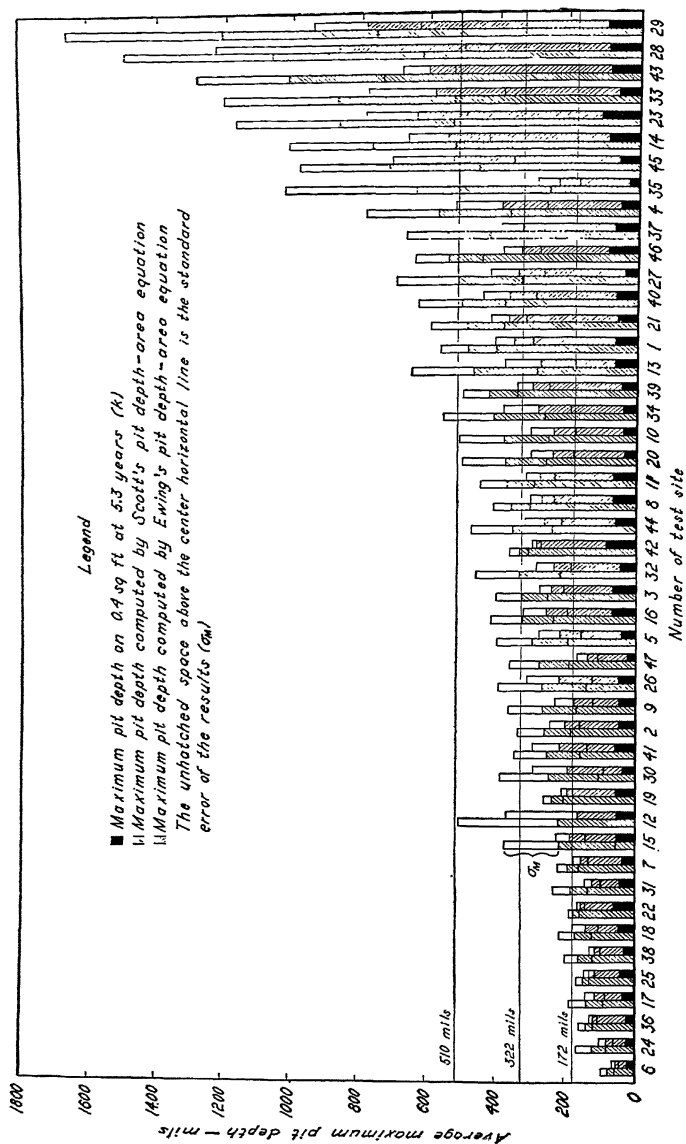
FIGURE 18.—Estimated maximum pit depth on 1,000 feet of 30-year-old 8-inch pipe.

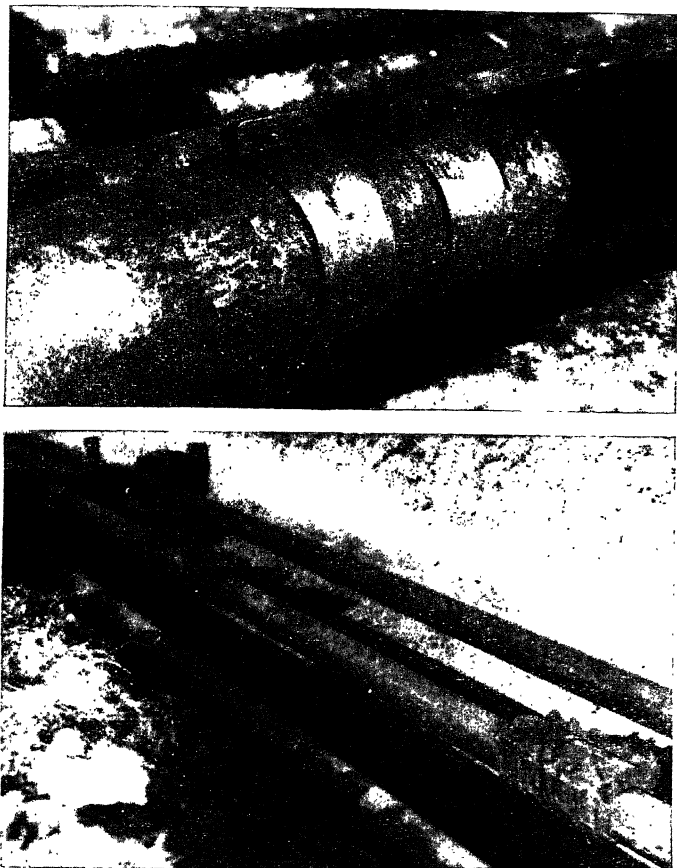
FIGURE 20.—*Two types of leak clamps.*
Top, home made, and bottom, commercial leak clamps.

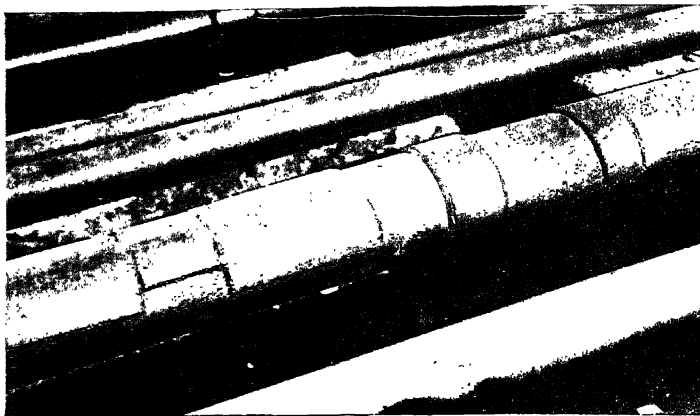
FIGURE 21.—“Half-sole” (welded patch) method of pipe repair.

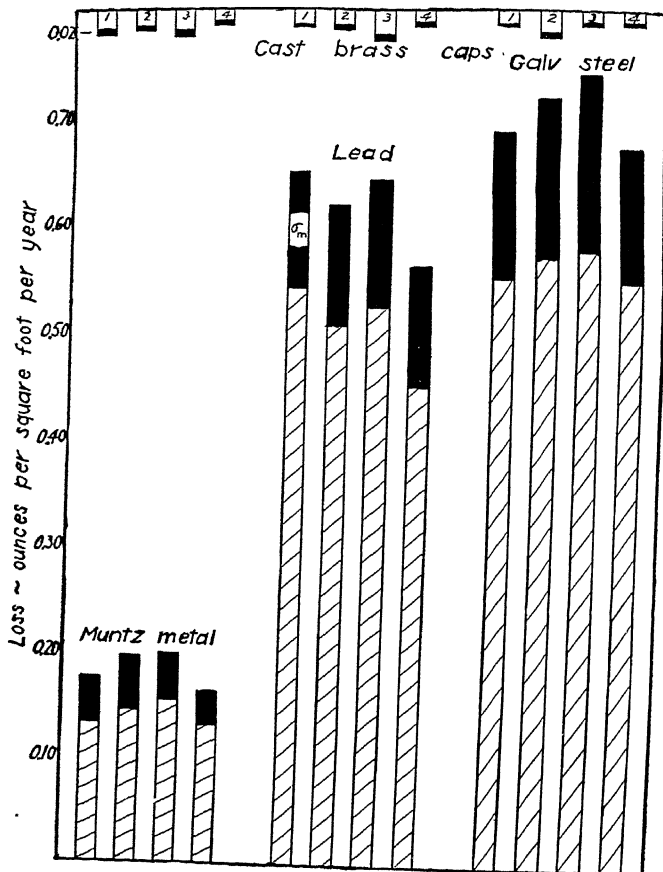
FIGURE 22.—Average rates of corrosion of cast-brass fittings and attached nipples in 15 soils.

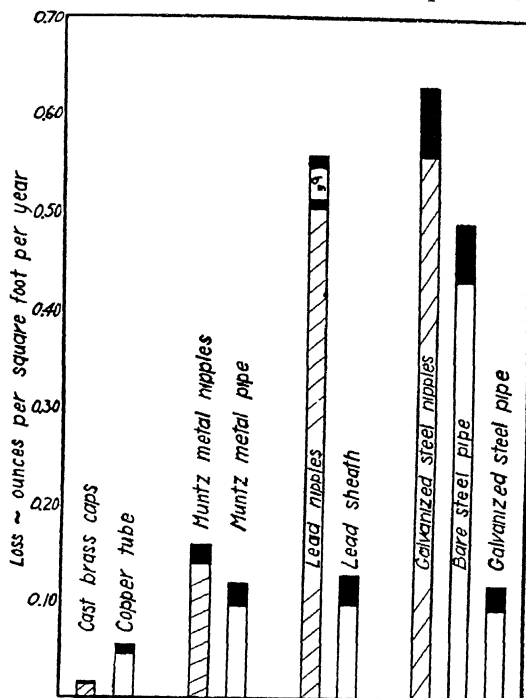
FIGURE 23.—Effect of interconnecting different metals.

each material on all soils. Figure 23 permits a comparison of these losses with losses of similar materials unaffected by galvanic action. It was evident that the connecting of the different materials accelerated the corrosion of the nipples, and reduced the corrosion of the cast caps. The intensity of the galvanic corrosion was affected by the relative areas of

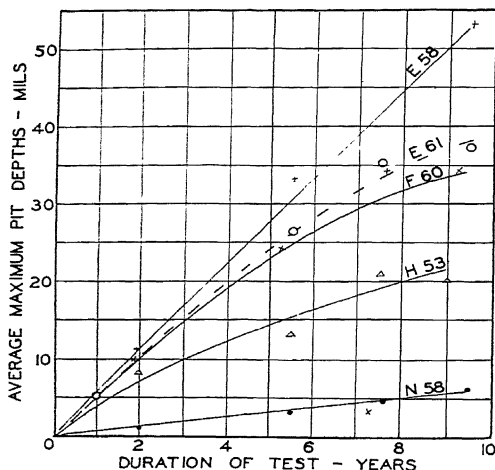
FIGURE 27.—Pit-depth-time curves for several copper-alloy specimens.
See tables 55 and 57 for identification of soils and specimens.

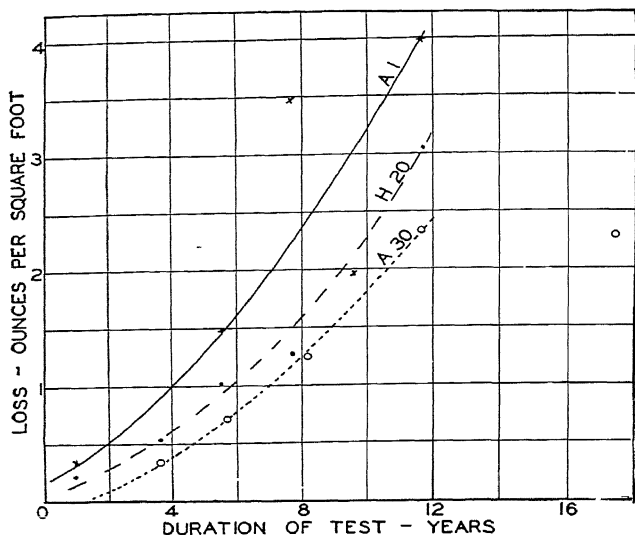
FIGURE 28.—Loss-of-weight-time curves for lead sheath in different soils.

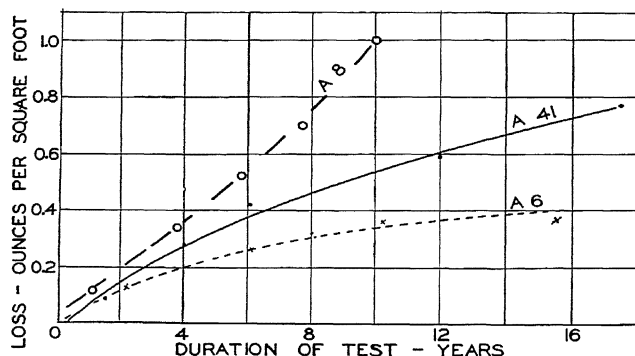
FIGURE 29.—Loss-of-weight-time curves for lead sheath in different soils.

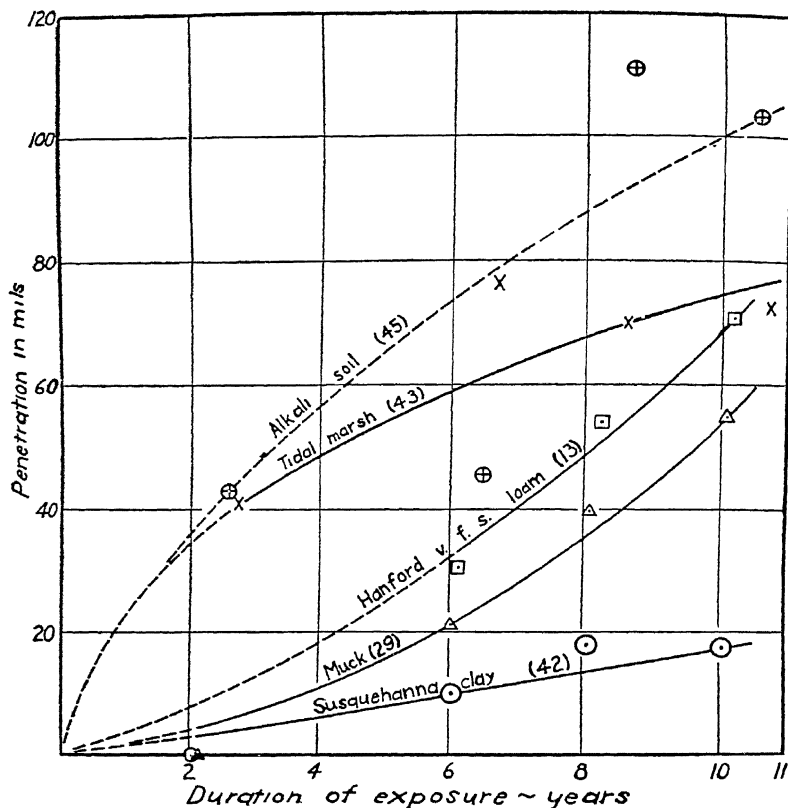
FIGURE 31.—Relation of the maximum penetration of zinc to the duration of exposure.

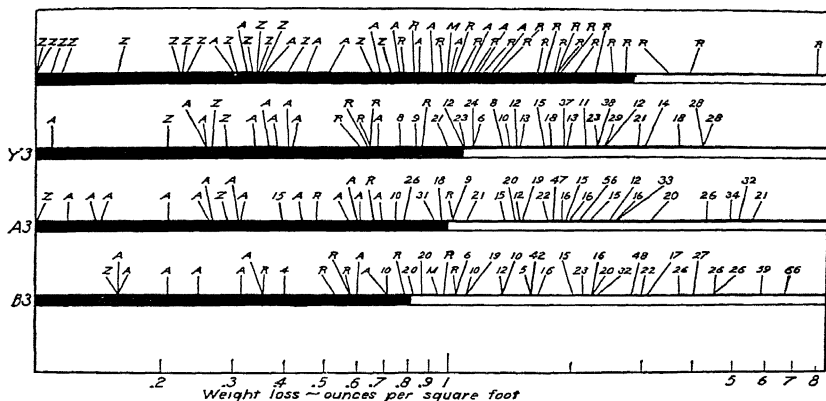
FIGURE 34.—Correlation between losses of weight and condition of galvanized specimens as determined by inspection.

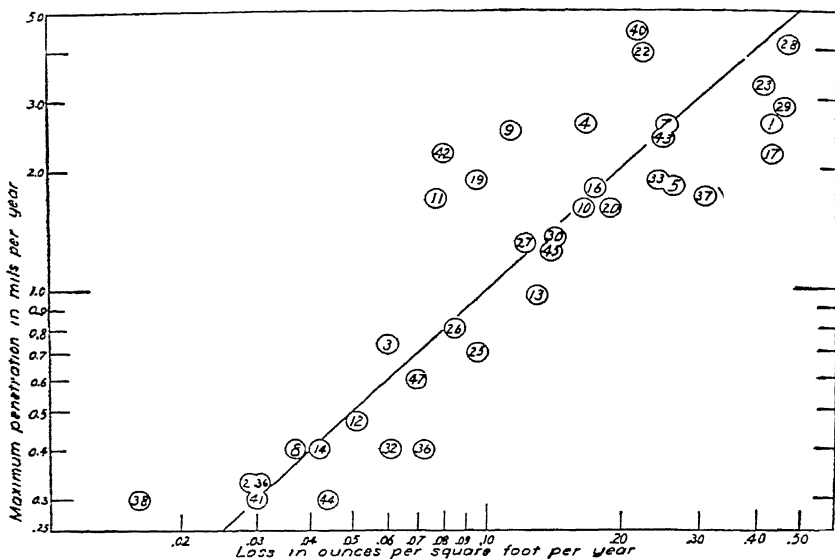
FIGURE 35.—Correlation between rates of loss of weight and rates of penetration on galvanized specimens.

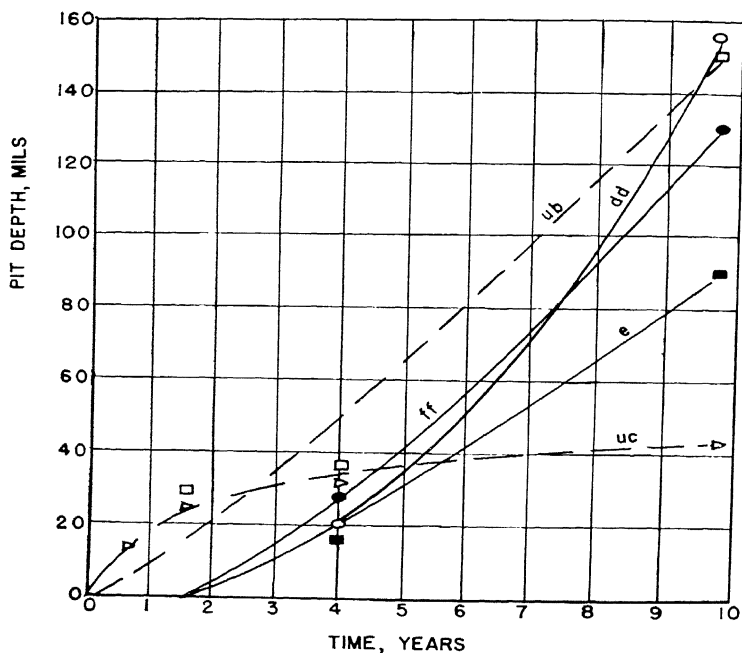
FIGURE 41.—Pit-depth-time curves for coatings applied to boiler tube at American Petroleum Institute site, XIII.—Müller clay.

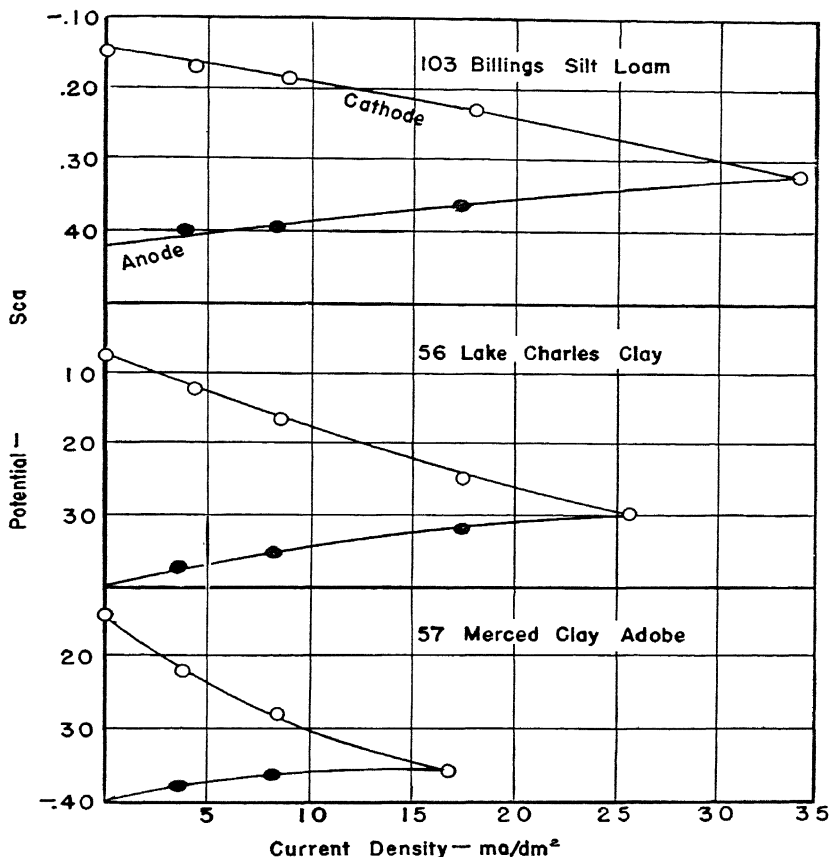
FIGURE 42.—Current-density-potential curves.

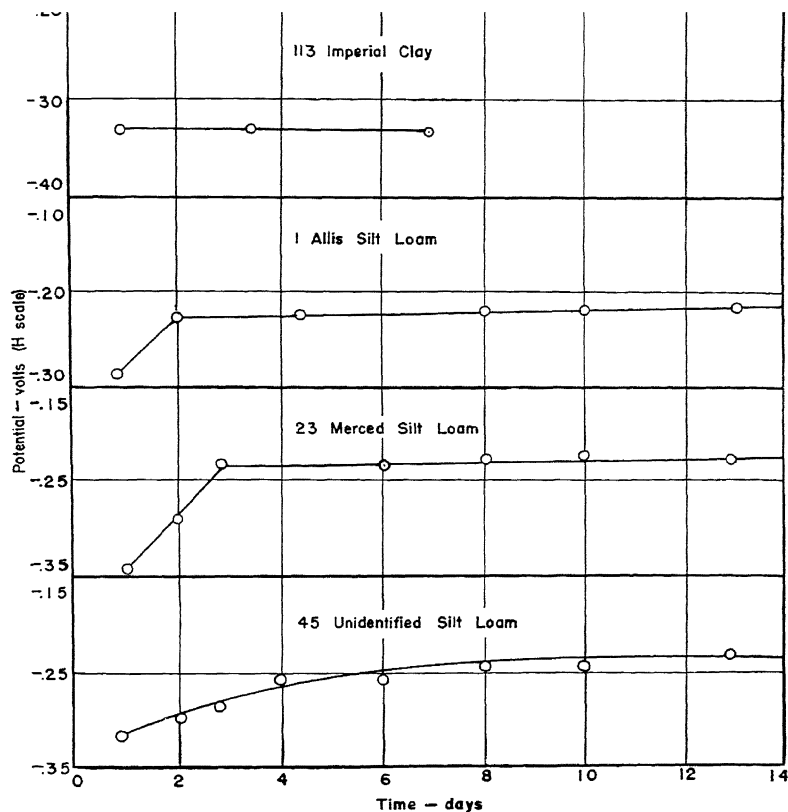
FIGURE 43.—Relation between corrosion potential and time.

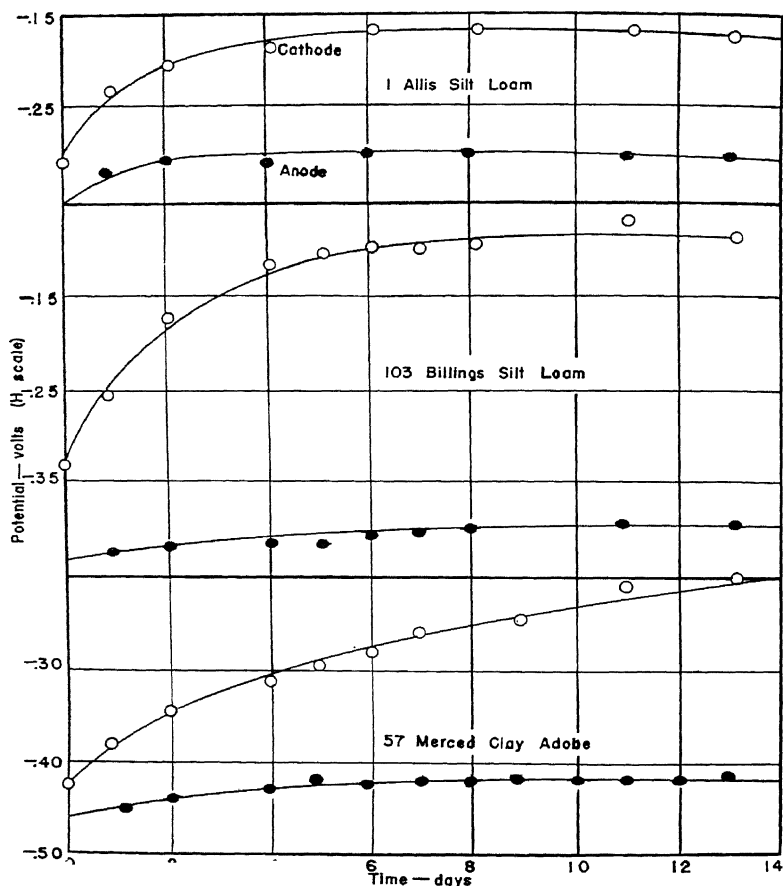
FIGURE 44.—Potential-time curves for the anode and cathode.

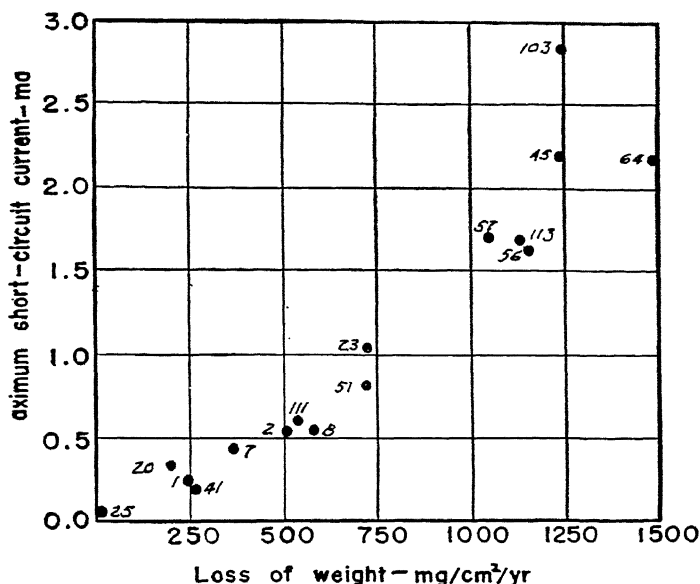
FIGURE 45.—Correlation between maximum short-circuit current and loss of weight of the anodes.

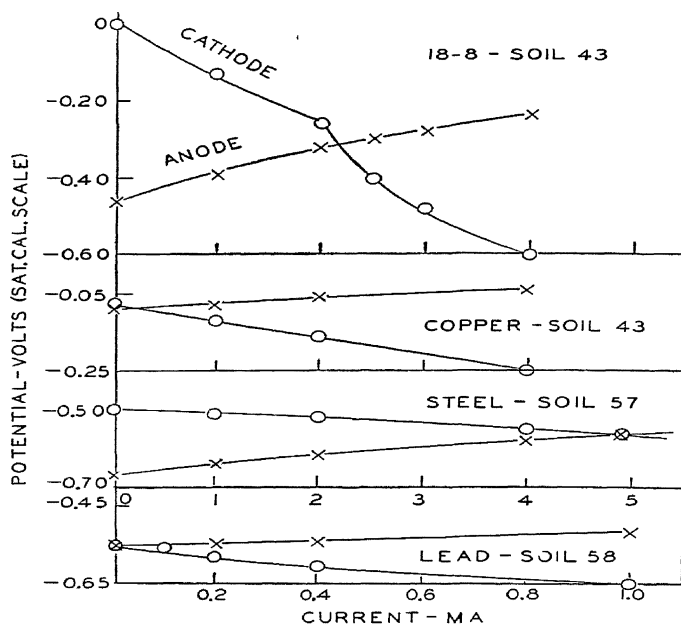
FIGURE 46.—Corrosion under cathodic control.

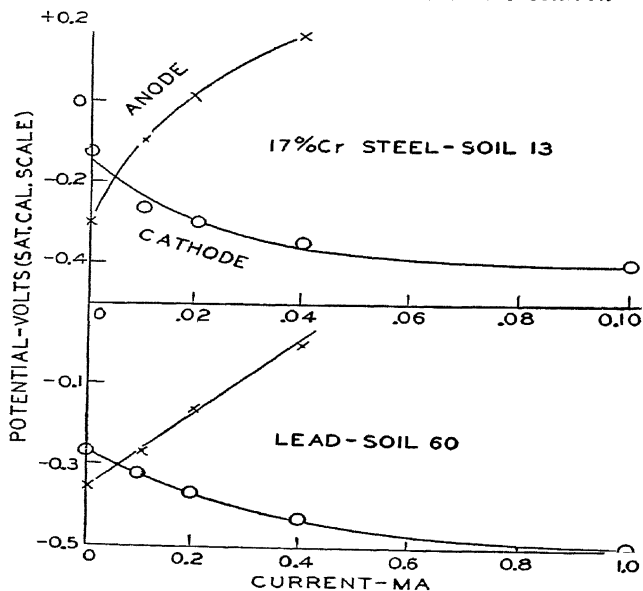
FIGURE 47.—Corrosion under anodic control.

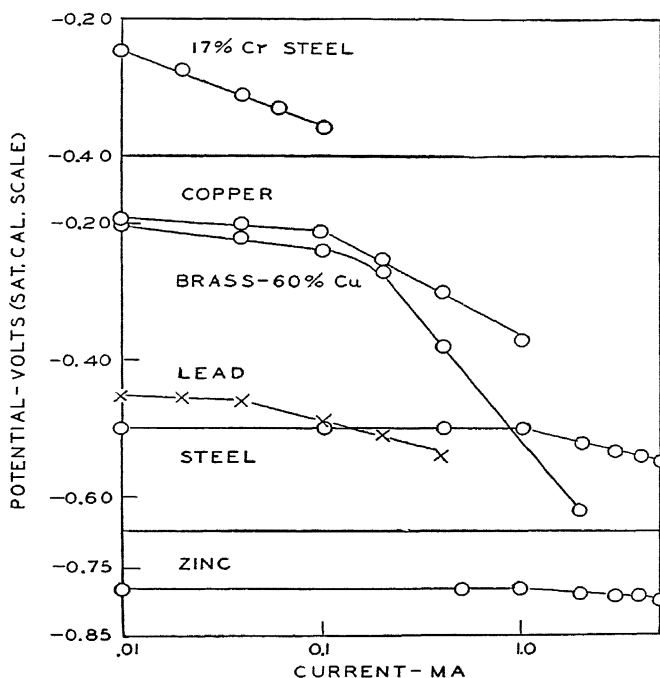
FIGURE 48.—Current-potential curves for the cathode in Docas clay.

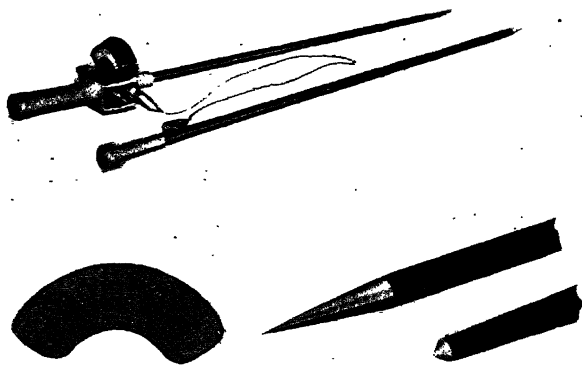
FIGURE 49.—*Shepard soil resistivity meter.*

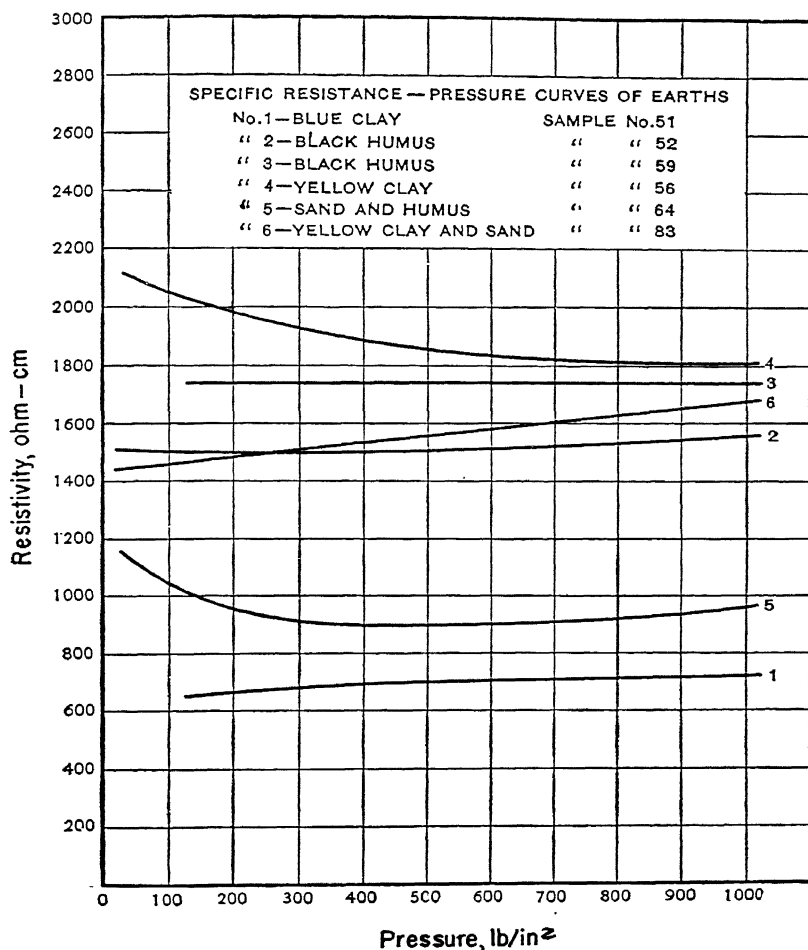
FIGURE 53.—Specific resistivity of soil at different pressures.

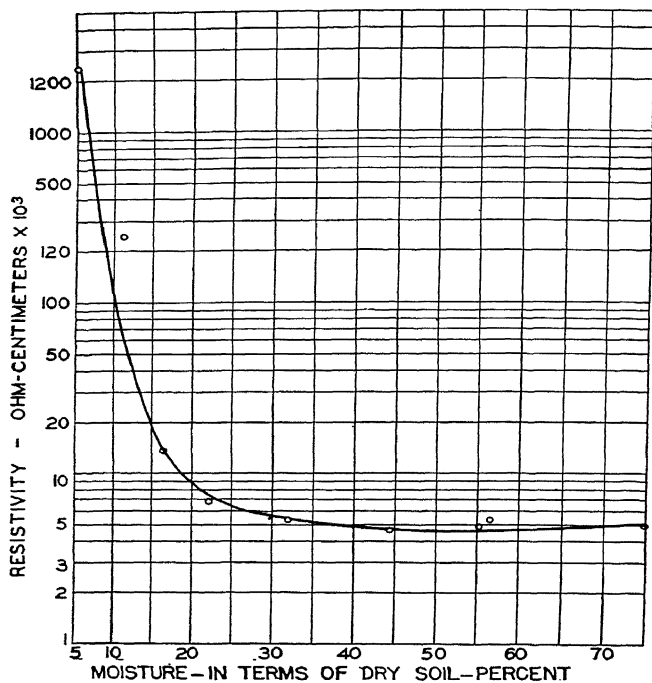
FIGURE 54.—Effect of moisture content on soil resistivity.

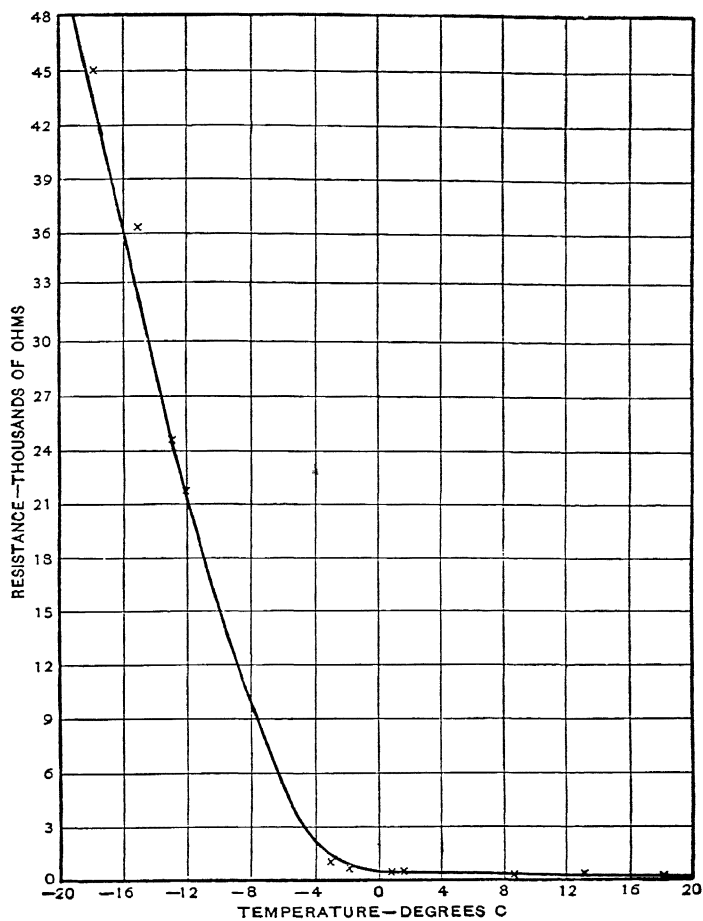
FIGURE 55.—Effect of temperature on earth resistance.

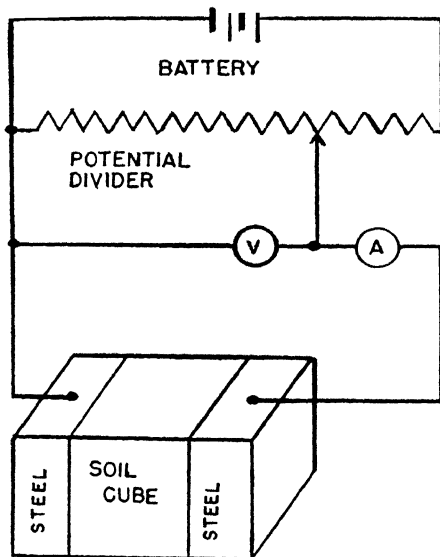
FIGURE 56.—Putnam apparatus for testing for potential corrosivity.

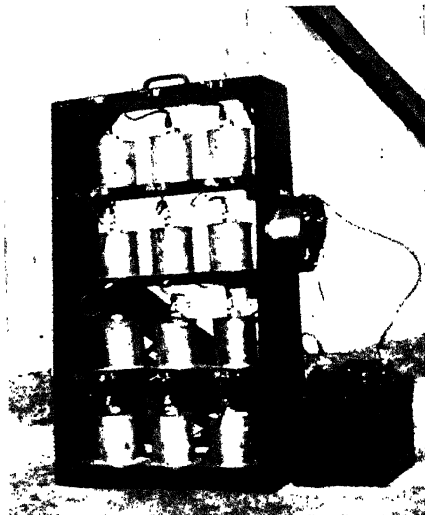
FIGURE 57.—Corfield apparatus.

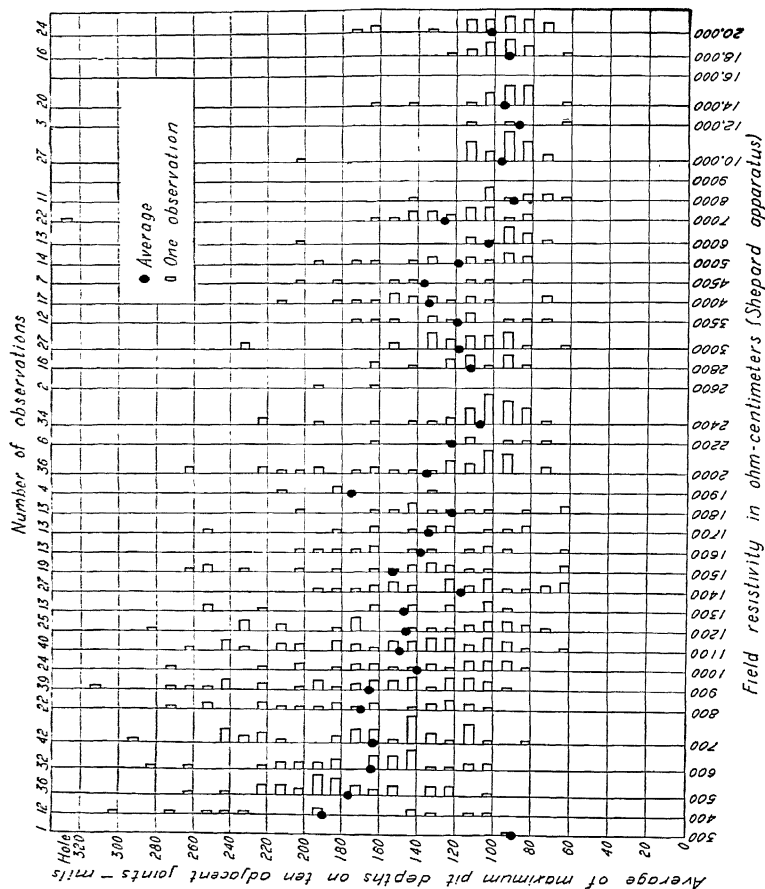
FIGURE 60.—Relation between soil resistivity measured in the field and the average of the depths of the deepest pits on the 10 sections of pipe nearest the place at which the resistivity was measured.

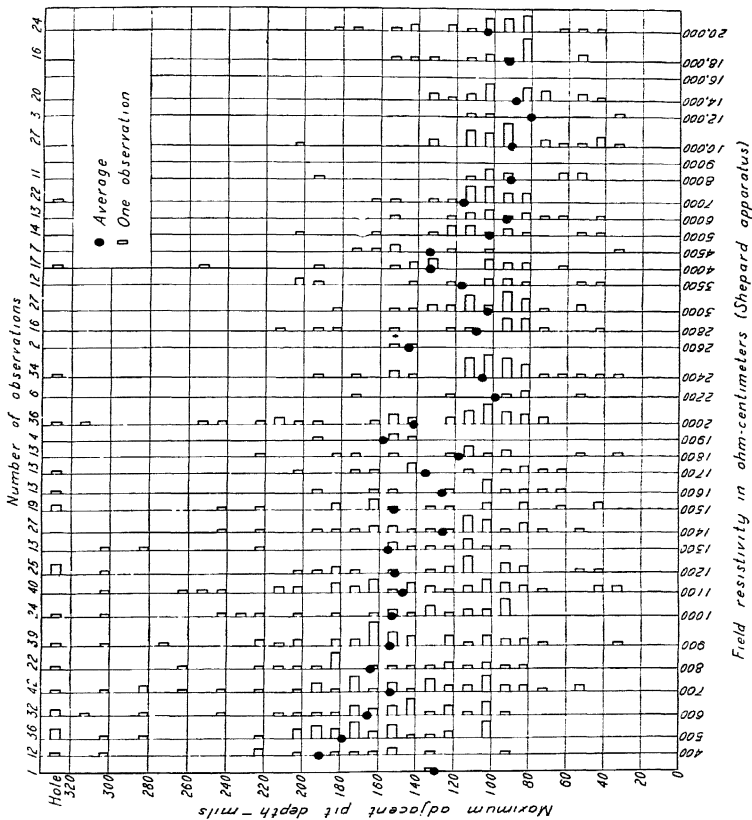
FIGURE 61.—Relation between the field resistivity of the soil and the maximum pit depth on a section of pipe nearest the place at which the soil resistivity was measured.

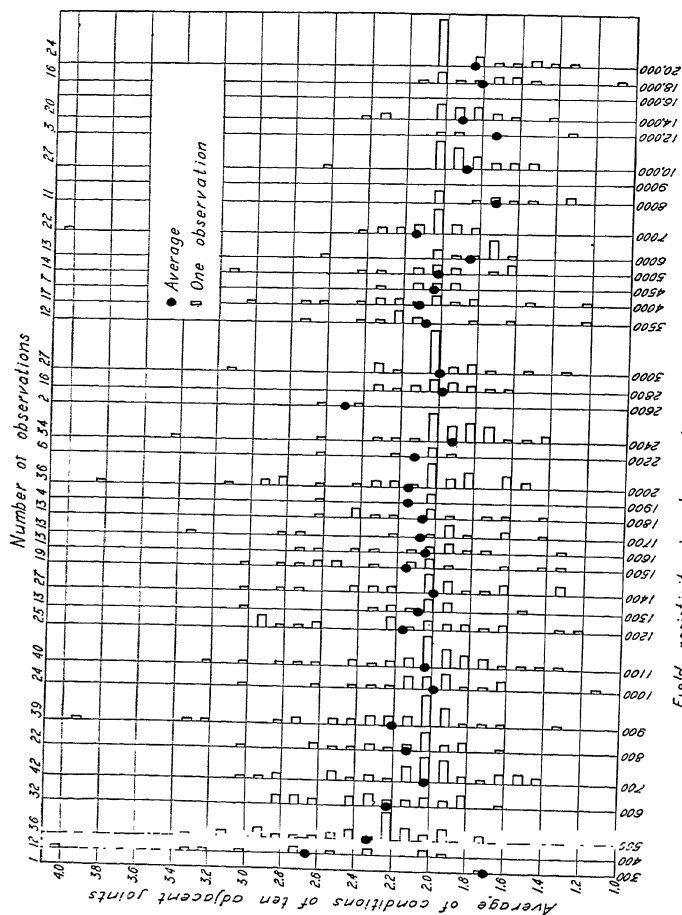
FIGURE 62.—Relation of the field resistivity of the soil to the average of the conditions of the 10 sections of pipe nearest the point at which the resistivity was measured.
The condition of the pipe was determined by visual inspection.

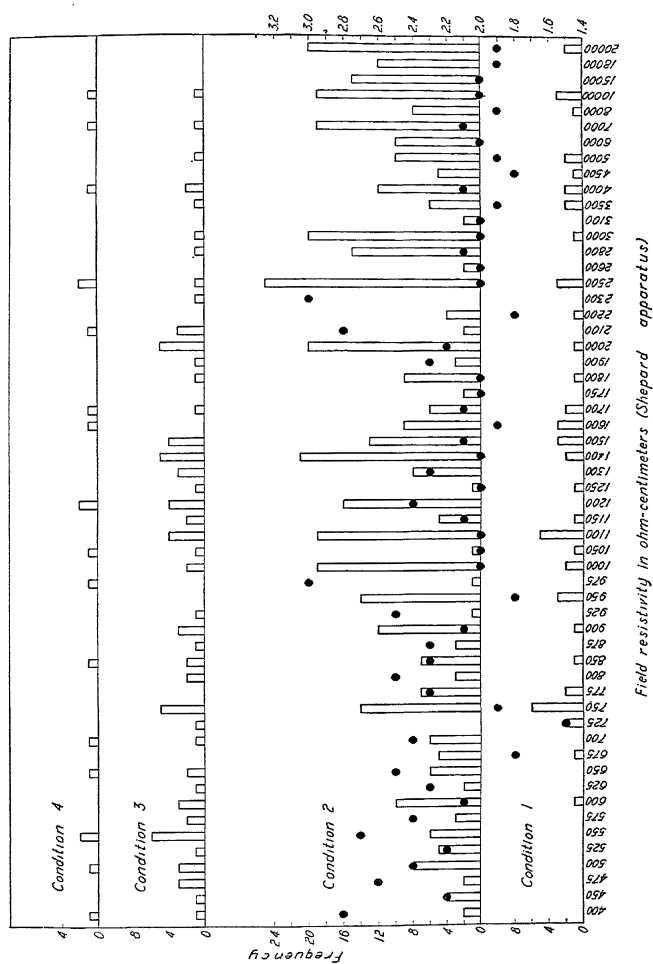
FIGURE 63.—Relation of the resistivity of the soil to the frequency of occurrence of pipes of conditions 1 to 4 (left-hand ordinate) and to the average of the conditions of the pipes (right-hand ordinate).

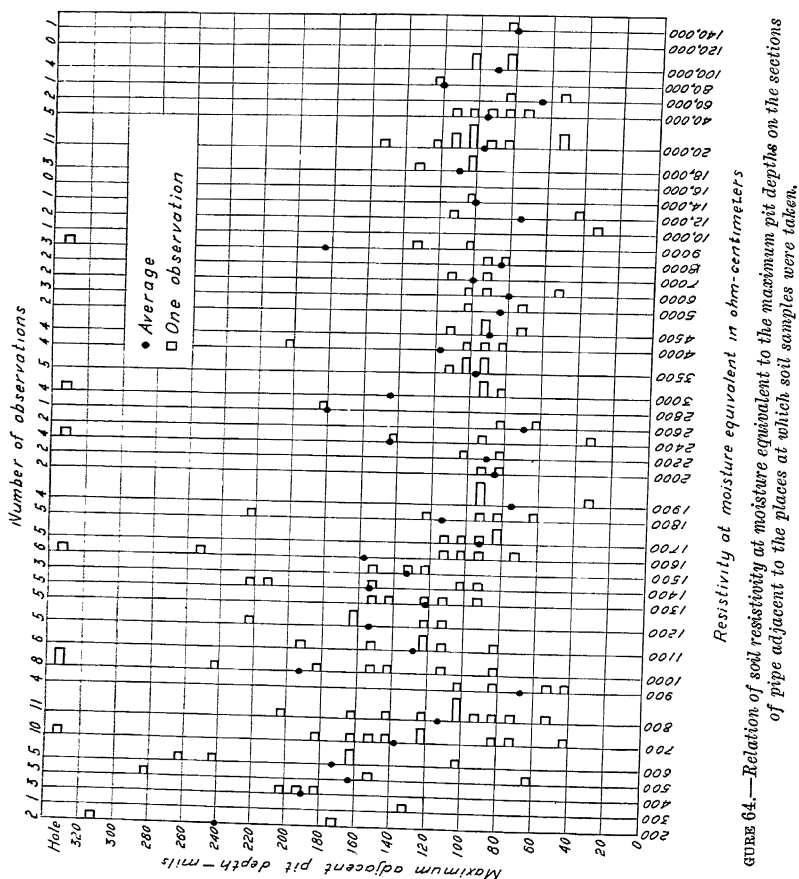
FIGURE 64.—Relation of soil resistivity at moisture equivalent to the maximum pit depths on the sections of pipe adjacent to the places at which soil samples were taken.

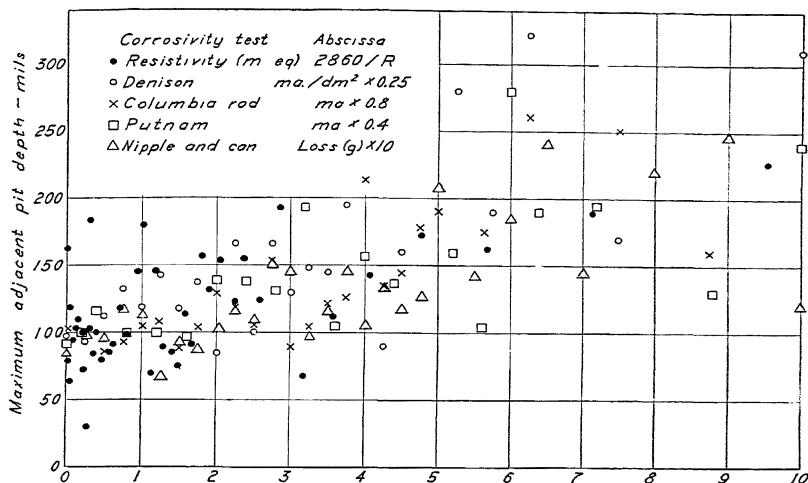
FIGURE 65.—Comparison of corrosivity of soil as indicated by the maximum pit depths on sections of pipe adjacent to places where soil samples were taken with results of various soil tests.

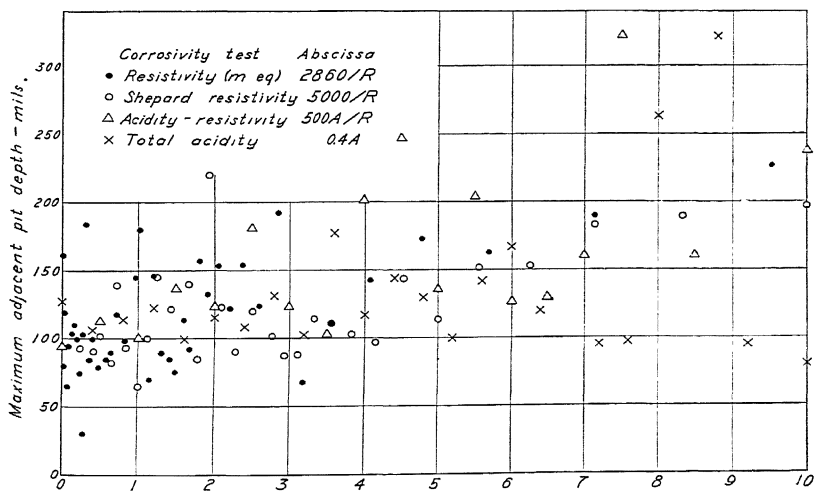
FIGURE 66.—Comparison of corrosivity of soil as indicated by the maximum pit depths on sections of pipe adjacent to places at which soil samples were taken with results of various soil tests.

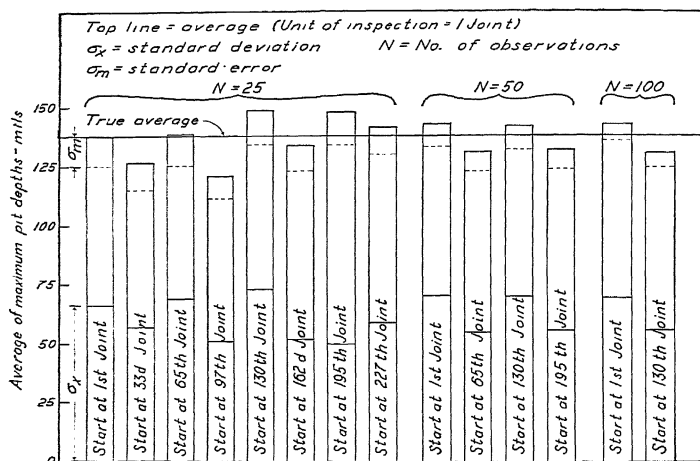
FIGURE 67.—Effect of the starting point and the number of inspections on the observed average of maximum pit depths on sections of a pipe line.

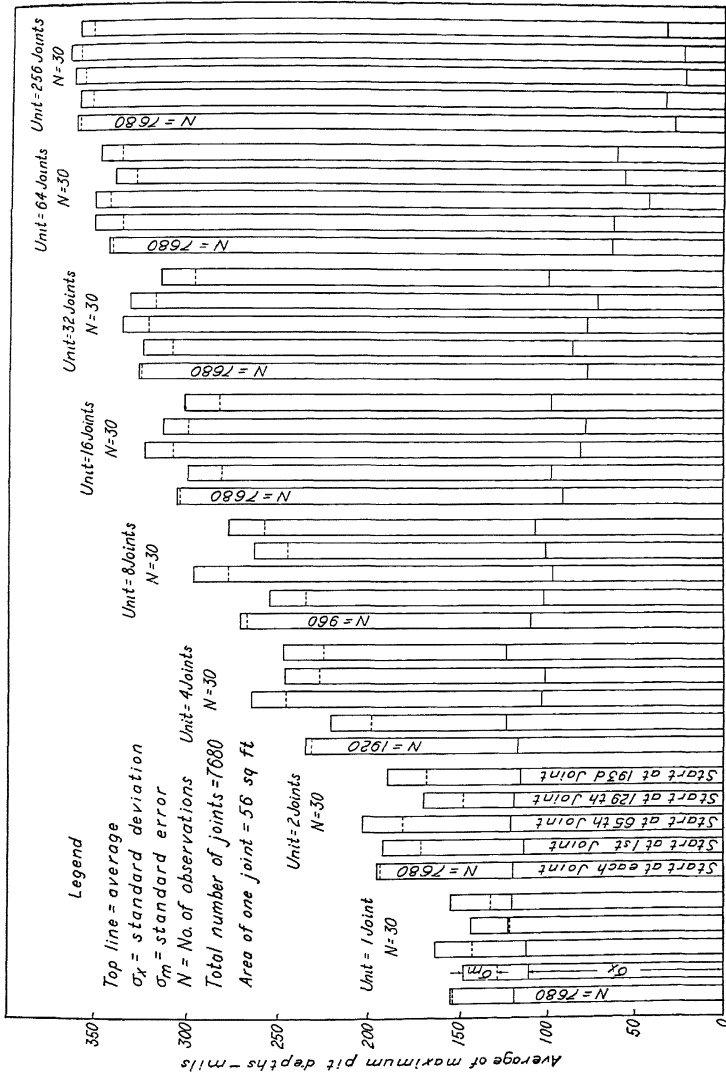
FIGURE 68.—Effect of the point at which inspections were started and the area inspected on the computed average of the maximum pit depths.

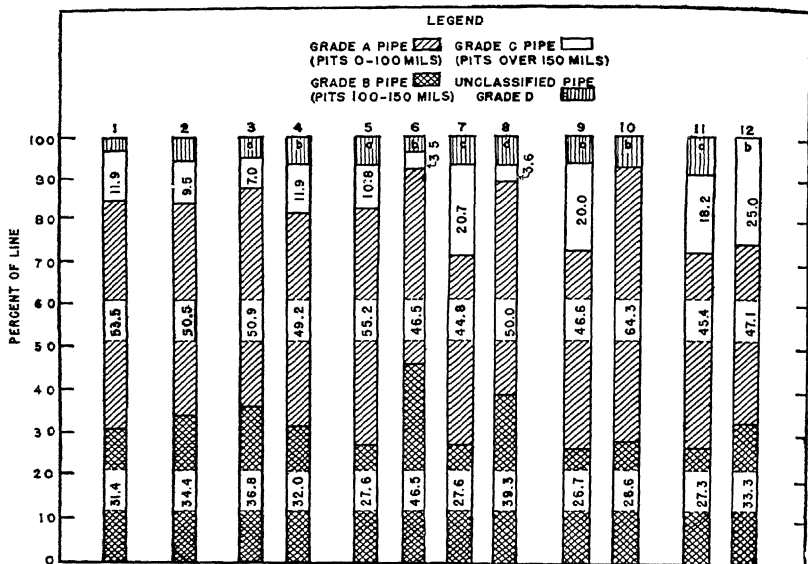
FIGURE 69.—Effect of method of inspection on apparent condition of a pipe line.

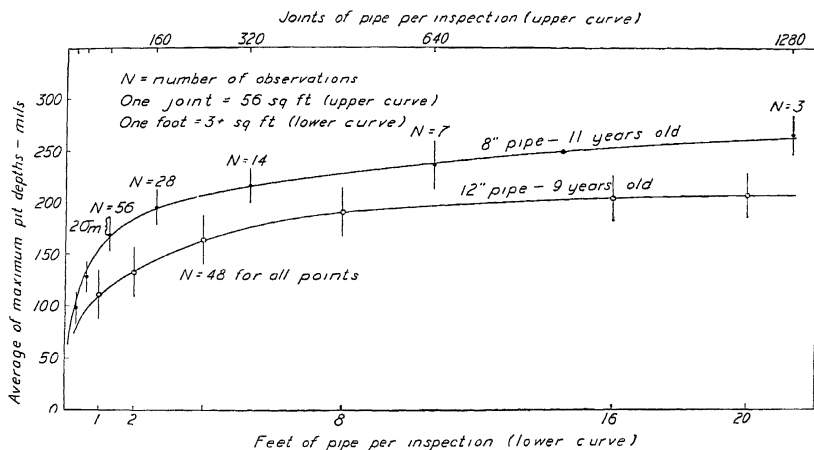
FIGURE 70.—Relation of area of pipe inspected to the maximum pit depths on each area.
